Geological conservation of natural and cultural heritage: the Italian experience in the ‘Siq’ of Petra

Keywords: Rock slope consolidation, Risk Management, Petra Archaeological Park, UNESCO World Heritage site.

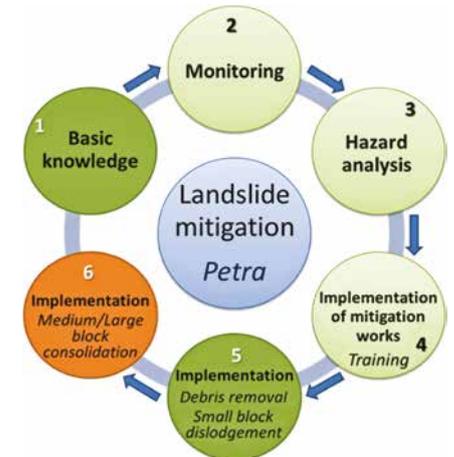
Fig. 2 – UNESCO's ‘Siq’ Stability Programme methodological approach.

der the supervision of UNESCO as the final stage, although not yet completed, of the methodological process illustrated in Figure 2. An outline and main results of such works are reported in the following paragraphs.

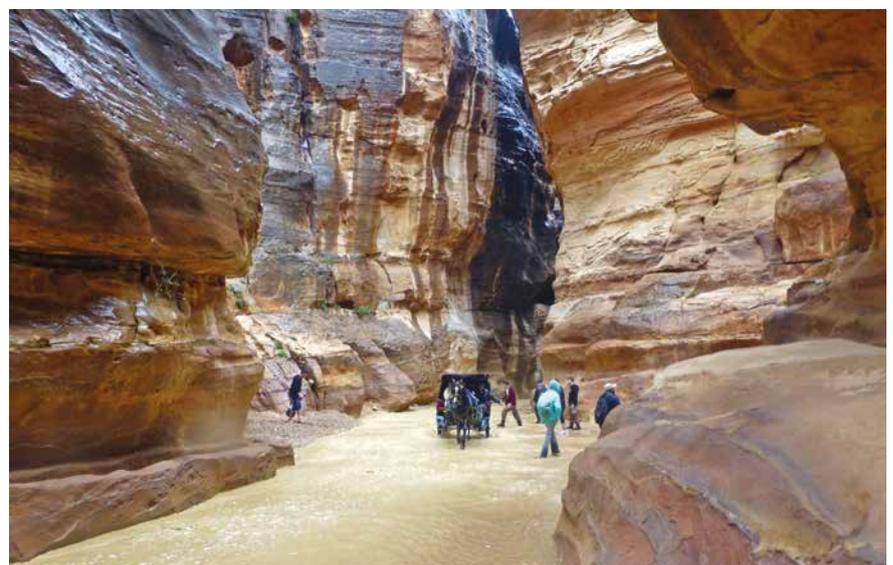
Fig. 3 – Flash-flood in the ‘Siq’.

as of the path. The ‘Siq’ being one of the main channels of the Wadi Musa catchment, collects a series of lateral steep channels that convey superficial water during short and intense rainfall events causing quite frequent flash-floods (Fig. 3).

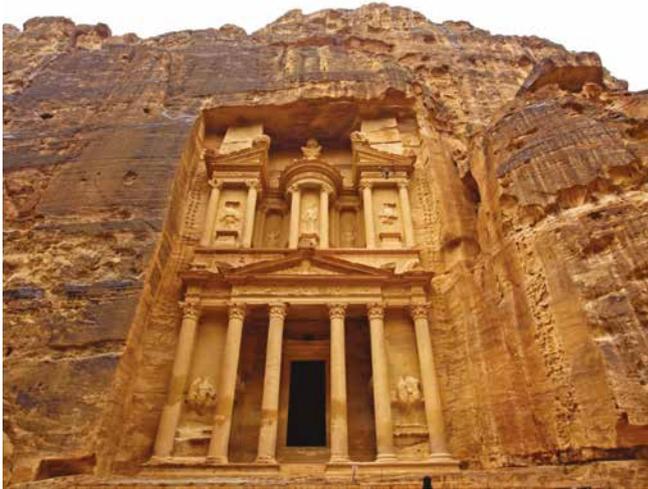
Fig. 4 – View of Al-Khazneh ('the Treasury').

used as building and decorative sandstone. The majority of the rock monuments of Petra were almost entirely cut in the Umm Ishrin formation due to its good mechanical strength and facility to hand-carving (Amireh *et al.*, 2001) (Fig. 4).

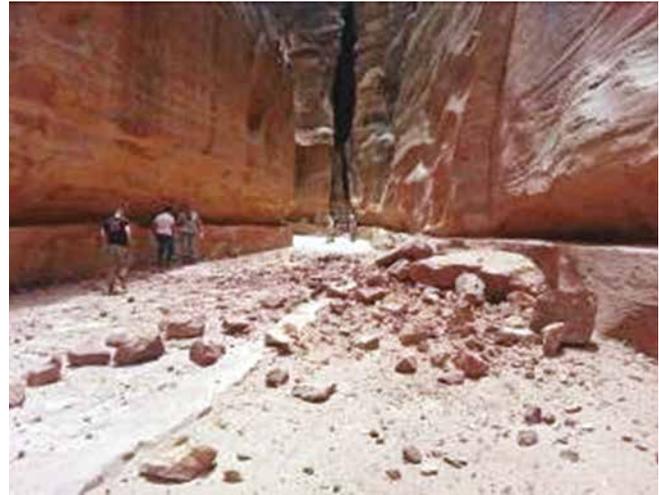
Fig. 5 – Rock fall occurred in the 'Siq' in May 2015.

Slope failures in the ‘Siq’ of Petra generally occur along pre-existing discontinuities and their triggering is mostly associated with short-term factors depending mainly on climatic parameters (i.e. temperature/humidity changes) and seismicity factors (Delmonaco *et al.*, 2013; 2014). In the last two decades, several landslide events, mostly rock falls and rock slides, with variable magnitude (volumes from $< 1 \text{ m}^3$ to $> 10 \text{ m}^3$) have occurred in the ‘Siq’ (2009, 2015) and in the core area of the site (2009, 2010, 2016, 2020) (Fig. 5). A brief description of such events is summarized in Table 1.

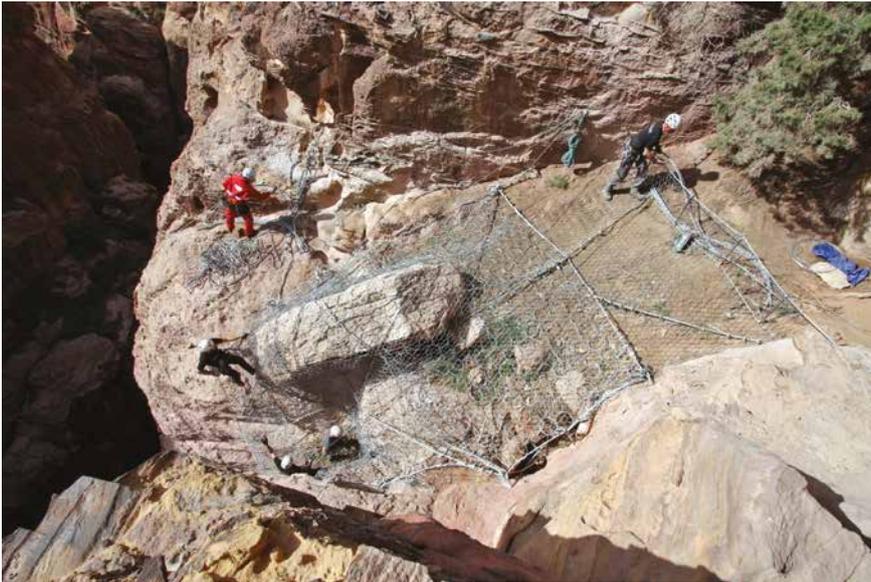
Fig. 9 – Consolidation of a rock block in the 'Siq' sector 9 (2019).

stability phenomena (Delmonaco *et al.*, 2017a). In 2018, after a first consolidation of a block in the 'Siq' sector 9 (Fig. 9), the Phase IV of the project was devoted to rock slope consolidation works of large blocks as the most challenging and difficult engineering activity so far undertaken in the 'Siq' of Petra. In July 2019, a further on-site surveys using climbing techniques was performed by the whole project team (UNESCO, ISPRA, geologists and engineers) mainly in order to: a) complete the engineering geological survey and data collection; b) install geotechnical monitoring systems; finalize the project design of consolidation works for the selected

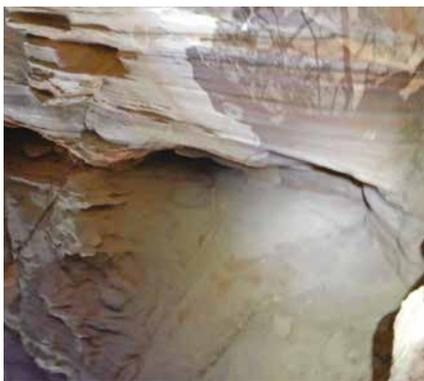
Fig. 12 – Base of the large block located in the 'Siq', sector 5.

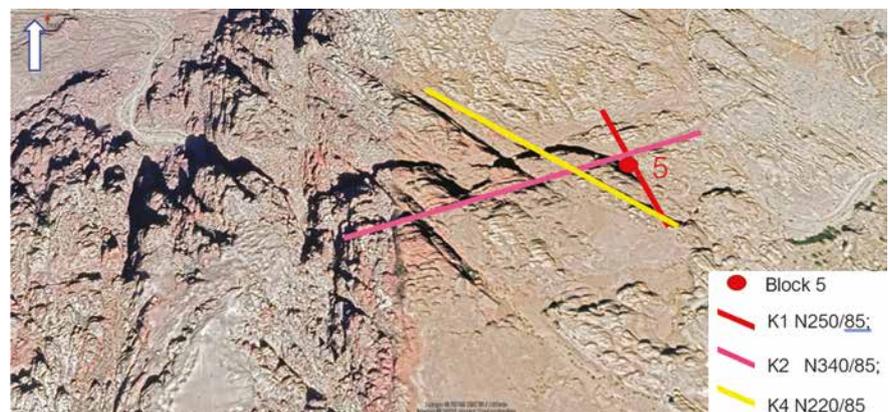
Fig. 14 – Orientation of the main discontinuities surveyed in the block of sector 5.

The block is characterized by the following main joint systems: joint set K1 N250-N70/85, joint set K2 N340-N160/85 and the rock bedding N90/5 (Fig. 13). The intersection between perpendicular, vertical joints and the horizontal bedding creates prismatic columns. The block is delimited by a vertical joint system. The three faces exposition of the block is approx. N250-N160-N340. The surveyed discontinuities system corresponds to the main and secondary regional tectonic structures (e.g. faults, joints) (Fig. 14).

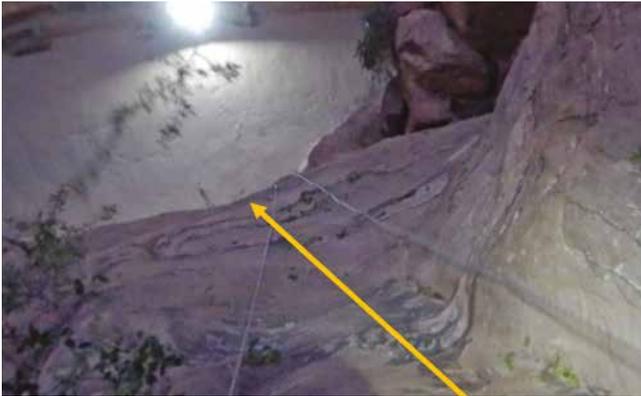
Fig. 15 – The arrow shows an old sliding plane surveyed S of block 5.

separates the block 5 from the rock slope. This sub-vertical joint is 4.10 m wide on the top of the block. South of block 5, the rock slope presents also an old sliding plane K1-1 (N250/70-80 (Fig. 15)). The rock quality of the slope face can be classified as good.

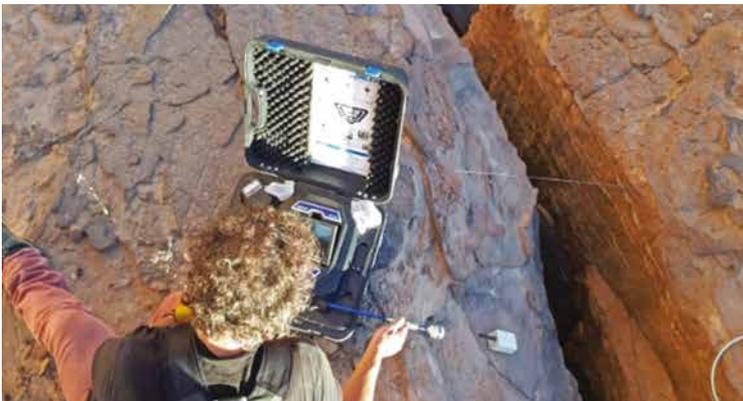
Fig. 17 – Endoscope log in set K1-2 (left), jointmeter in K1-2 (right).

scope logs and jointmeter (Fig. 17 and 18).

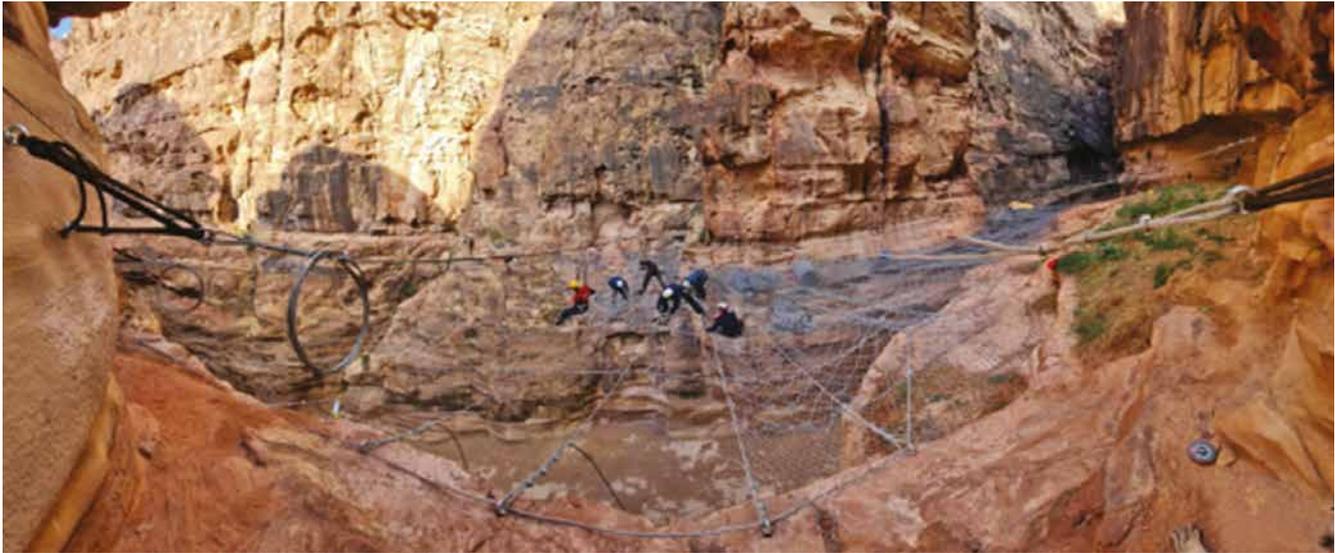
Fig. 23 – Construction of the protection net in the 'Siq'.

cal remains with sandbags and reinforced geotextile. The tourist passage was guaranteed by the construction of protective metal nets with wire ropes anchored

on the two opposite sides of the canyon, consisting of wire mesh panels supporting double-twisted rock fall protection nets covered with geotextile (Figg. 23-24).

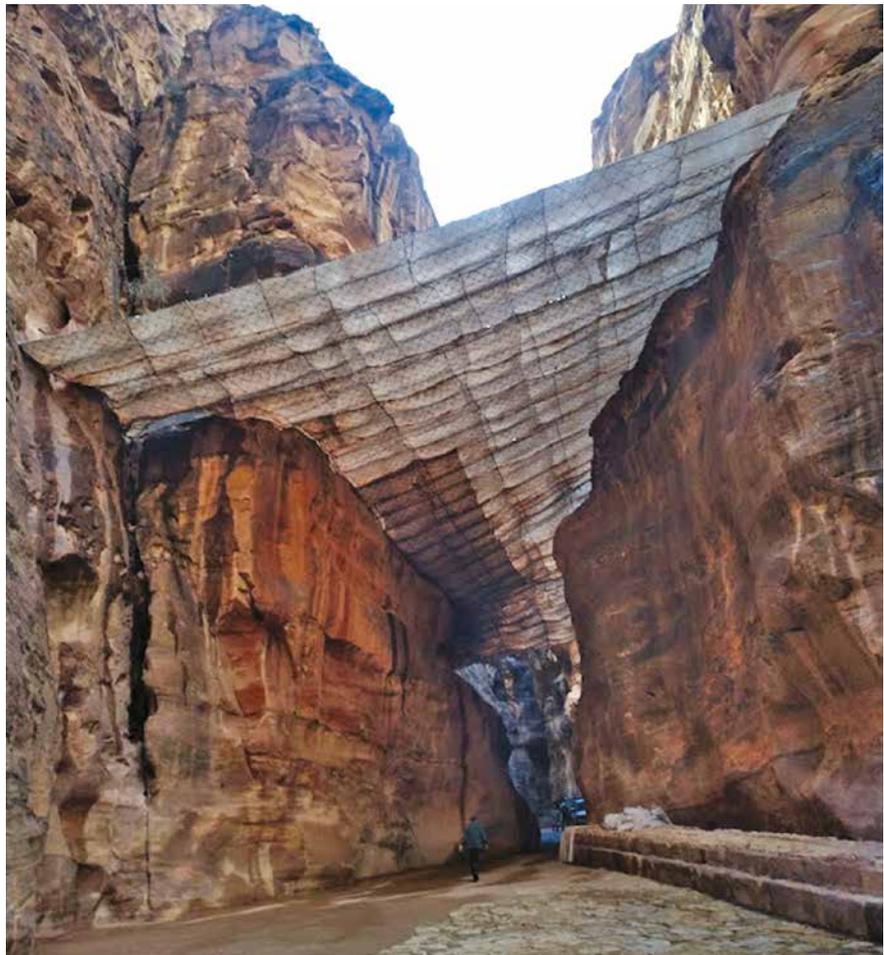
Fig. 24 – Final view of the protection net.

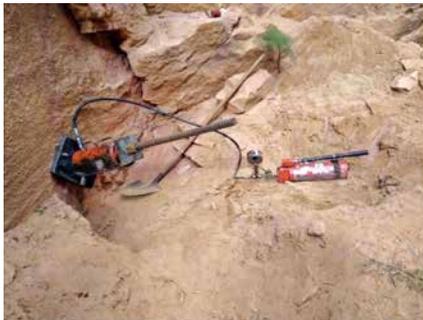
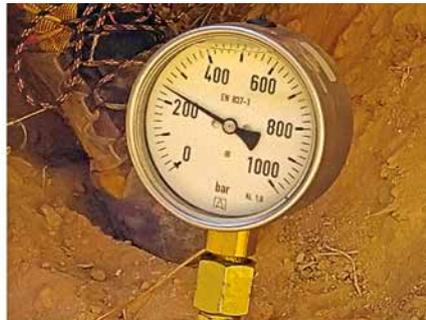
Fig. 29 – Pull-out test implemented in the ‘Siq’ of Petra.

mass where a pull-out test was carried out (Shu *et al.*, 2005). The pull-out test resulted in deformation of the system grout/bar without rupture (Fig. 29).

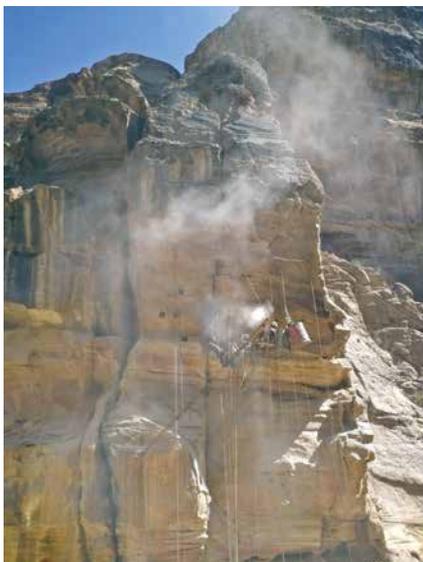
Fig. 30 – Vibrometer installed in the block 5 during the drilling operations.

The drilling operations for the anchors were monitored with a vibrometer (Fig. 30) which provided

data showing a negligible disturbance for the rock mass.

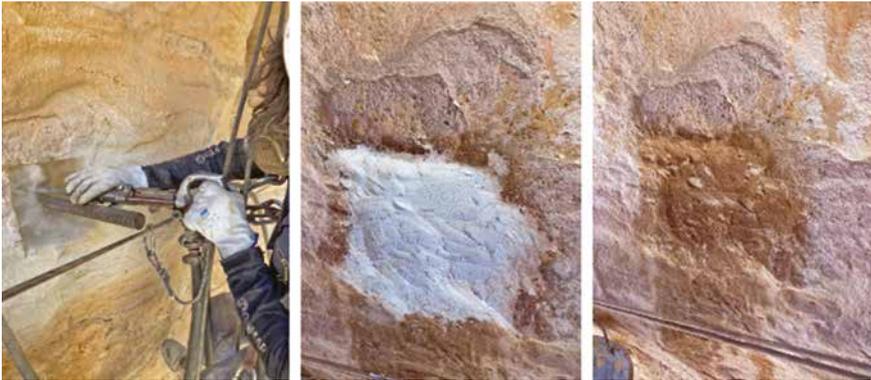
Fig. 31 – Head of anchor covered with mortar:

The operation of camouflage of the anchors works in the block 5 included the coverage of the head of the anchors with mortar mixed with local sand (Fig. 31-32).

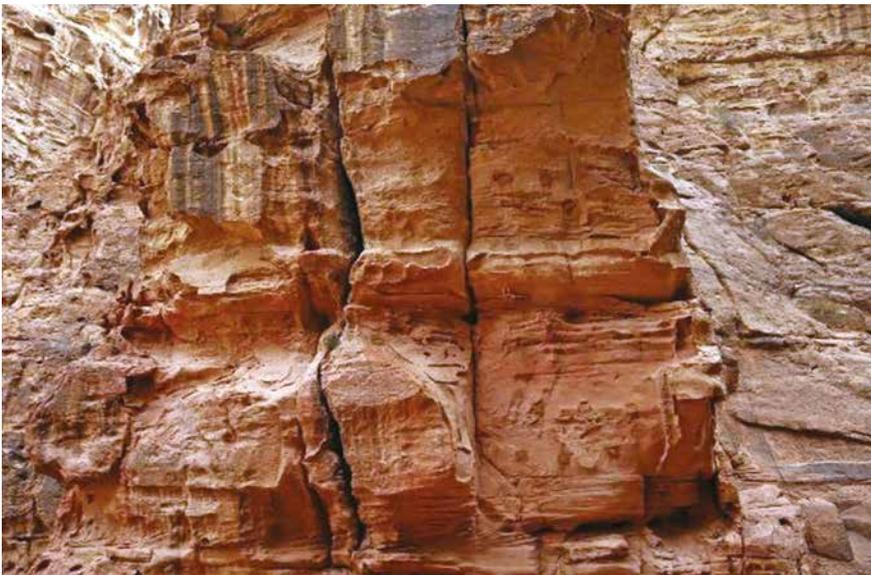
Fig. 32 – Final view of block 5 front after the consolidation works.
