# A tool for monitoring rockfall protection works and plan the maintenance: the case of the autonomous region of Valle d'Aosta

Rockfall net fences and drapery meshes constitute two of the most adopted protective structural works against rockfall hazard. During their life, they are subject to ageing, corrosion, and impact loads, with a consequent loss of efficiency or even effectiveness. Due to the variability of the environment and, more in general, to external conditions, a definition of a service life, although not unique but different product by product, is not achievable.

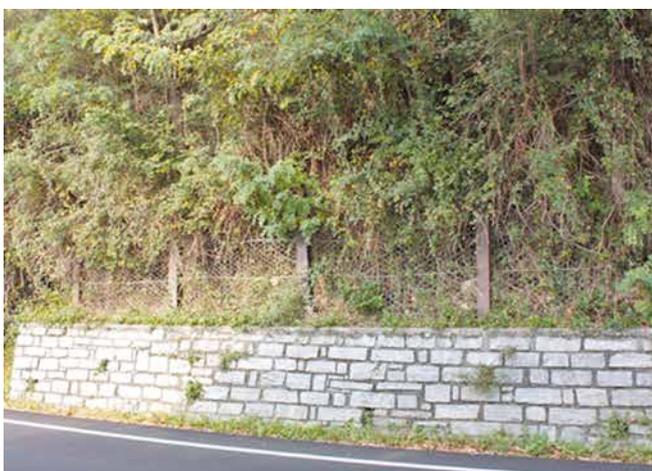
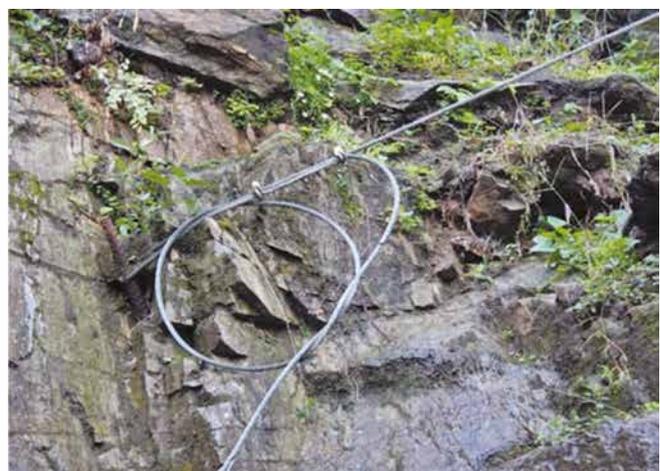
Fig. 1 – Installation errors, and unsuitable or not certified technologies.

Neglecting the design aspect, several damages frequently observed relate with installation errors, and suitable or unsuitable certified technologies (Fig. 1). Focusing directly on degradation and ageing incorrect/absent maintenance procedures, among the problems, the ones related to vegetation, directly interacting with the works or otherwise influencing their performances, are the most common. Corrosion has been frequently observed in several components, even in the anchors, where disrupted. Accumulation of debris, due also to impacts with energy much smaller than the design one, as well as impacts of element differing from rock blocks, i.e. trees after some severe or unexpected

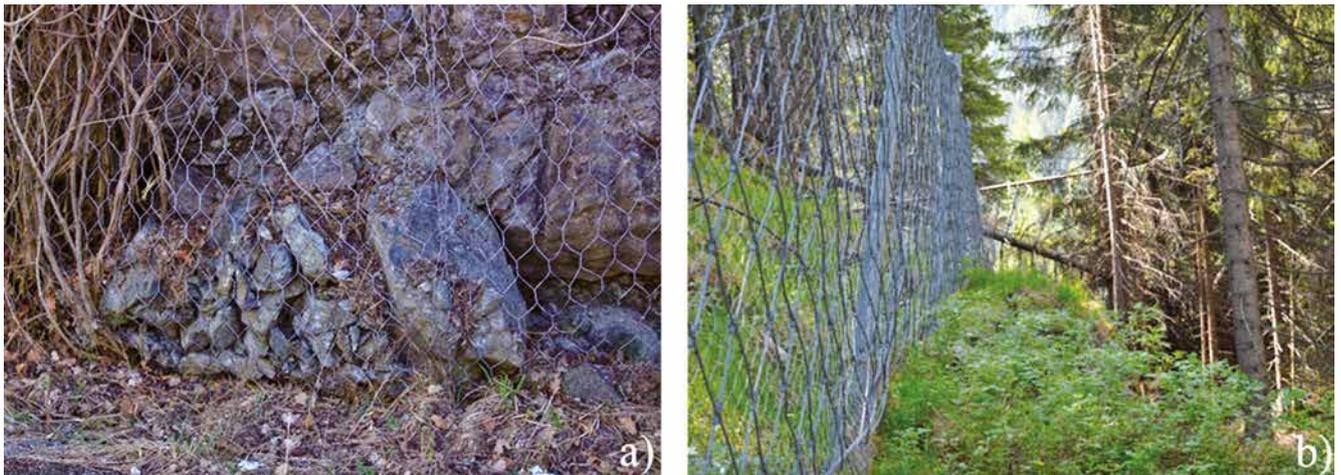
Fig. 2 – Accumulation of debris, due also to impacts with energy smaller than the design one (a), and impacts of element differing from rock blocks, i.e. trees after some severe or unexpected climatic events (b).

climatic events, represent recurring situations highlighted during inspections (Fig. 2).

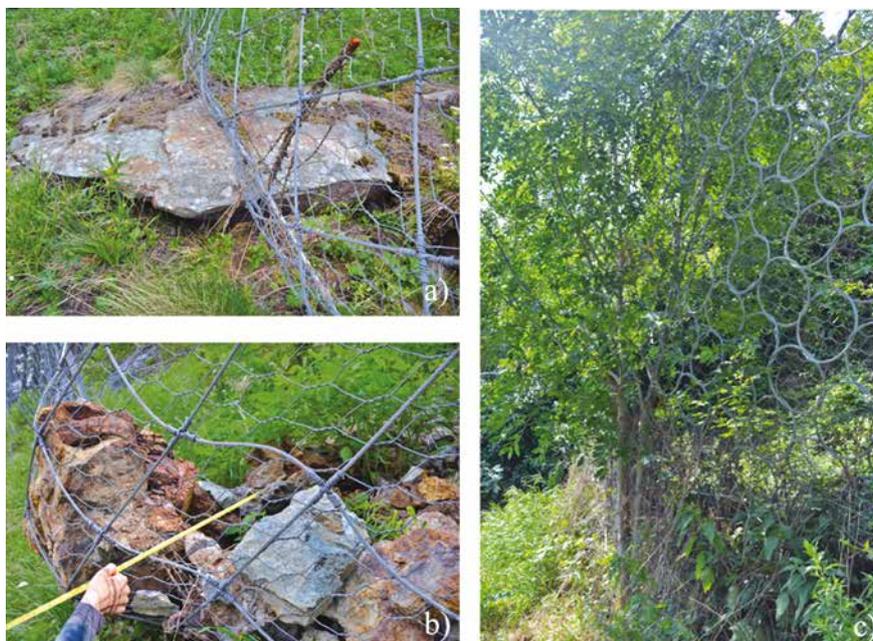
Analysing in detail those net fences that display a high need of interventions, the presence of significant void at the foot of the barrier reveals to be the major issue, together with the presence of elements limiting the deformation capacity of the barrier (Figg. 4 and

5). Both these aspects are highlighted in the 62% of the samples (and in many cases they are observed together), while in 31% the presence of debris/blocks/notches in the net is shown. Considering also  $P_{tot}$  values, this indicator is lower or equal 15% in all the cases, revealing that in the great majority the indicator  $A$  mostly affects the results. This implies that, even though high priority levels of maintenance are required, the maintenance procedures to adopt would involve only a single aspect/damage, i.e. closing the net at the bottom, removing blocks or trees

Fig. 4 – Frequent observed damages: voids at the foot of the barrier (a), debris/blocks/notches in the net (b), and elements limiting the deformation capacity of the barrier (c).

interacting with the net are the only actions required.

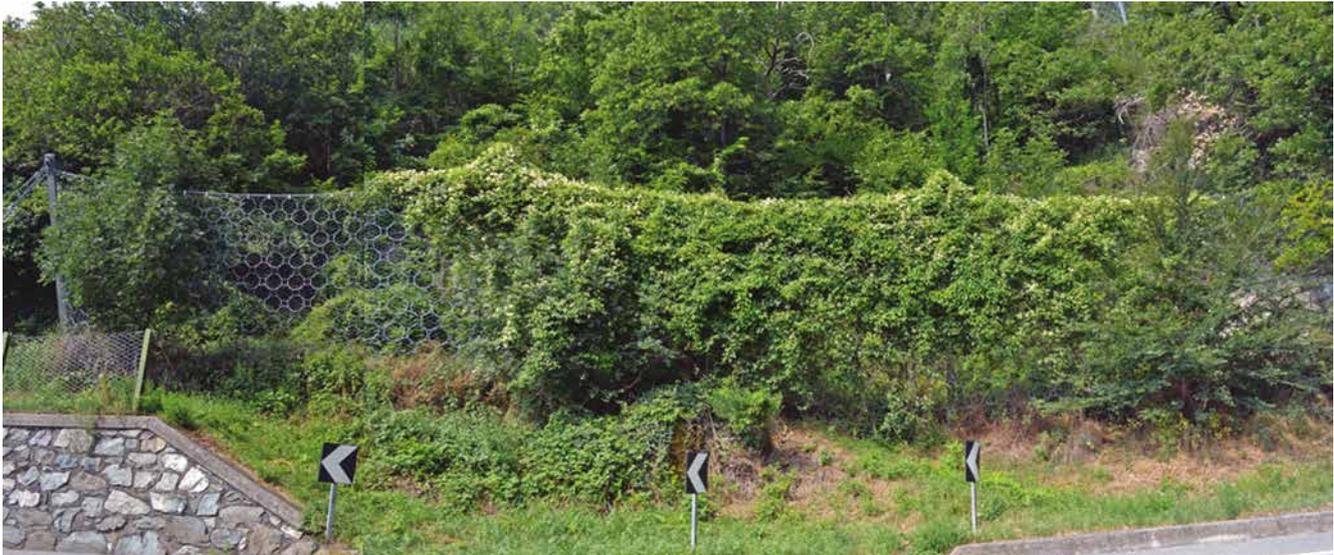
Fig. 6 – Presence of dense vegetation.

Among the potential damages which can lead to, at least, a medium or medium-high maintenance need, corrosion is the most observed, together with small voids at the bottom and little presence of elements interfering with the net. A very frequently observed potential damage, even secondary, is related to the presence of vegetation, which can make difficult to see and inspect the barrier (Fig. 6). In many cases, thus, an operation of periodic vegetation clearance is strongly suggested. If not periodically removed, the vegetation can promote the occurrence of collateral damages, e.g. corrosion due to the humid environment, and for some species, the trunk could limit the deformation capabilities of the barrier or the sliding capacity of the breaks.
